## TEST REPORTION unless endorsed by This assessment/test report

No. : SZIN2311002595PL04\_EN

GNG Moisture Resistant Gypsum Board

Test Item: Breaking load

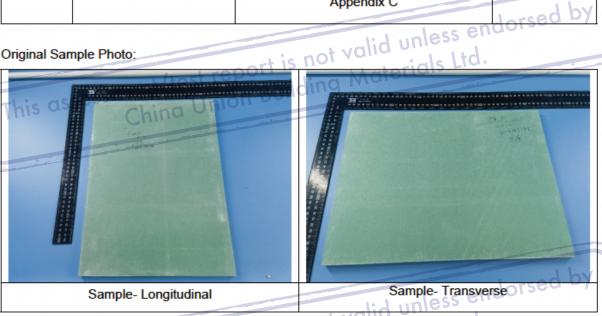
## Original Sample Photo:

2440×1220×12

Sample Description: See photo
